# Offshore geo-hazards to keep in mind during prospecting and exploration activities of the Jan Mayen Micro-Continent area.

Anett Blischke, Iceland GeoSurvey

Þórarinn S. Arnarson, National Energy Authority of Iceland

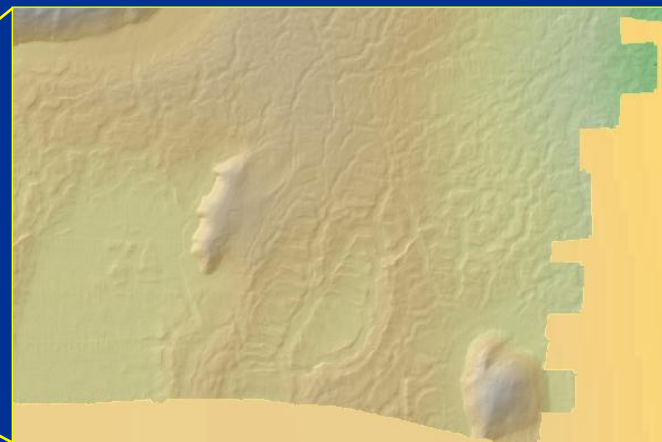
Possibly polygonal fault pattern related to de-watering of clay rich soft sediments.
